PRELIMINARY ENGINEERING REPORT

Birnie Avenue Bridge / Tunnel City of Springfield, MA

September 6, 2019

City of Springfield – Department of Public Works 70 Tapley Street Springfield, MA 01104

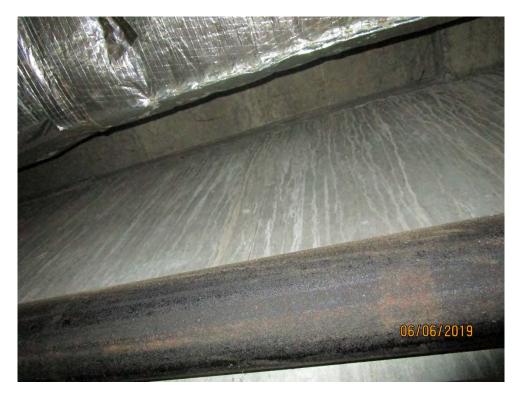
The concrete abutment stems are approximately 3 feet wide and bear on concrete footings approximately 10 feet wide. The structures are generally in good condition. There is efflorescence on the concrete abutment stems in areas of water infiltration. No major cracks or spalls were noted. There are approach slabs that sit each abutment. Each approach slab is 8 inches thick and 14 feet wide.

PHOTO 1: EVIDENCE OF WATER INFILTRATION AT NORTH ABUTMENT

- Excavate behind the abutments to expose the entire rear face of the abutment stems. Temporary earth retention will be required for the work to maintain traffic and to ensure stability of adjacent structures.
- Perform localized repairs to the back surface of the abutments.
- Install new spray-applied waterproofing membrane along the back face of the abutment stems.
- Backfill.

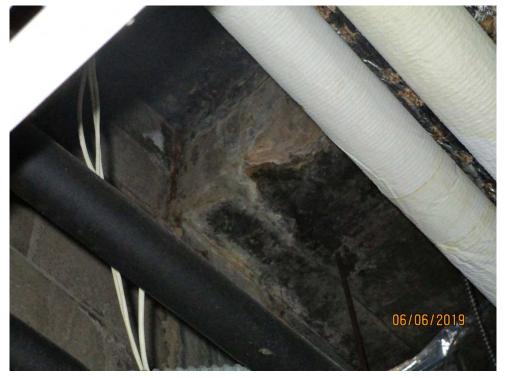
- Water was observed to be dripping off the bottom of the concrete slab in the northeast corner of the bridge, possibly down the atrium building exterior wall
- Water was observed to be infiltrating the tunnel through the joint between beam #1 and the concrete edge beam #1 near the north and south abutments

PHOTO 2: EFFLORESCENCE BELOW CONCRETE SLAB AT NORTHEAST CORNER OF BRIDGE

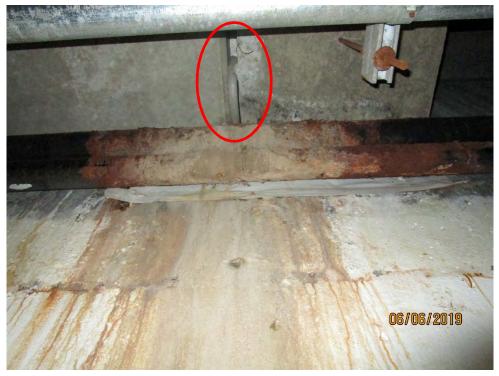
- Water was observed to be infiltrating the tunnel through the joint between beam #23 and the concrete edge beam #2 near the north abutment
- In general, the joints between the prestressed concrete box beams are leaking along the north abutment and water is running down the abutment face
- Water was observed to be infiltrating all utility bays. The stay-in-place metal forms and the steel angles that support them are exhibiting heavy rust and section loss.
- Water was observed to be infiltrating the tunnel at all four locations where Birnie Avenue curb lines cross over the bridge abutments

PHOTO 3: JOINT FAILURE AT NORTH ABUTMENT BETWEEN BEAM 23 & EDGE BEAM 2

- Install new bridge deck joints at both abutments.
- Excavate fill materials at the interfaces of the bridge / tunnel and the adjacent structures (school / atrium). Replace waterproofing materials at these interfaces and backfill.

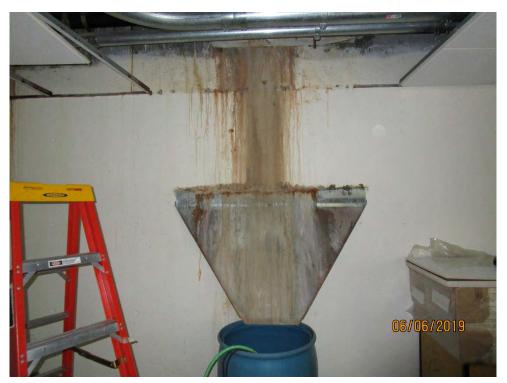
PHOTO 4: WATER INFILTRATION AT NORTH ABUTMENT BETWEEN BEAM 23 & EDGE BEAM 2

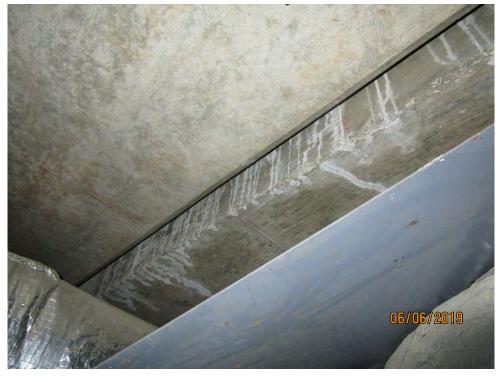
PHOTO 5: EVIDENCE OF LEAKAGE BETWEEN BEAM 23 AND EDGE BEAM 2

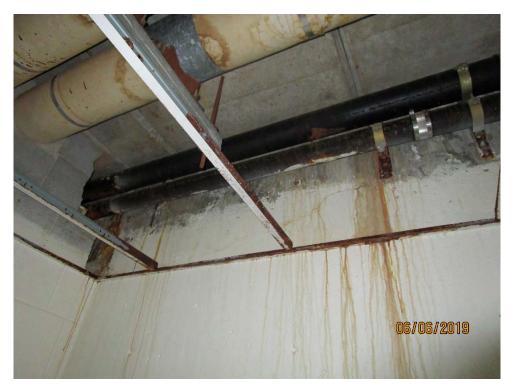
PHOTO 6: UNDERSIDE OF BEAMS 20-22 AT NORTH ABUTMENT

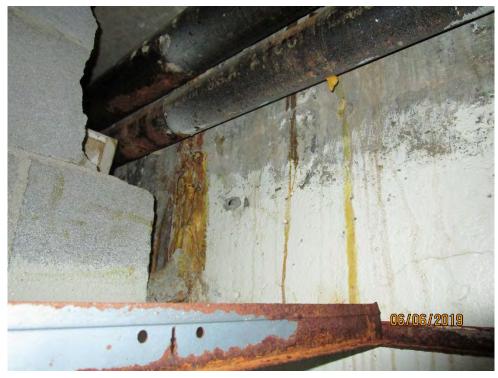
PHOTO 7: WATER INFILTRATION THROUGH NORTH ABUTMENT WALL BELOW BEAM 20

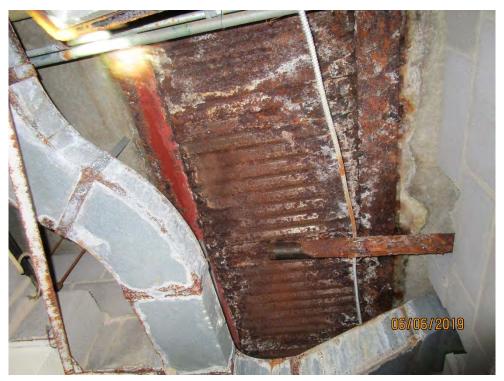
PHOTO 8: RUSTED ANGLES AND STAY-IN-PLACE FORM UNDER UTILITY BAY BETWEEN BEAMS 17 AND 18

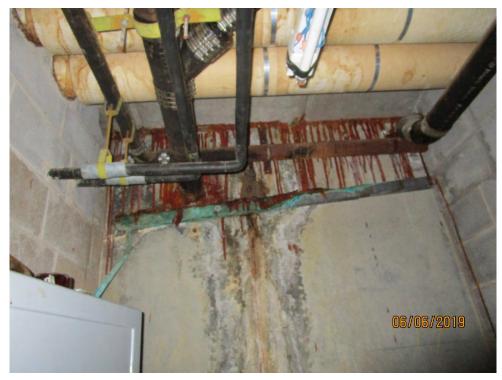
PHOTO 9: WATER INFILTRATION BETWEEN BEAMS 16 AND 17 AT BIRNIE AVENUE CURBLINE

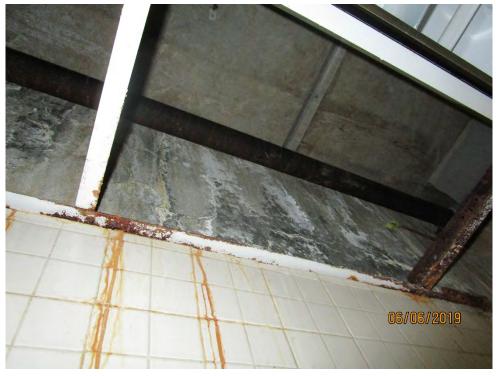
PHOTO 10: EFFLORESCENCE ON NORTH ABUTMENT BELOW BEAMS 14 AND 15

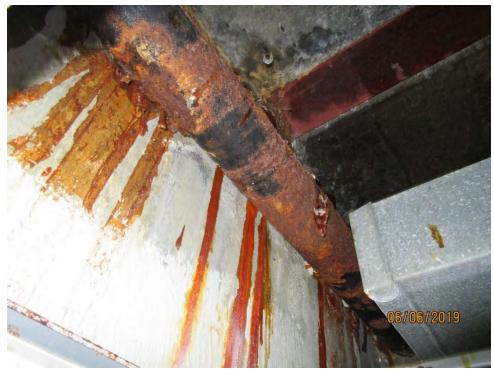
PHOTO 13: HEAVY RUST ON UTILITY CONDUIT UNDER BEAM 2 AT NORTH ABUTMENT

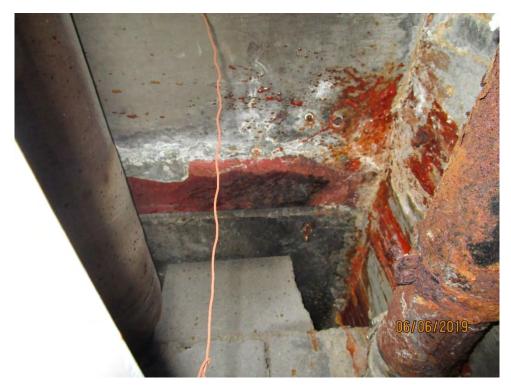
PHOTO 14: HEAVY RUST AT UTILITY BAY BETWEEN BEAMS 3 AND 4 AT NORTH ABUTMENT

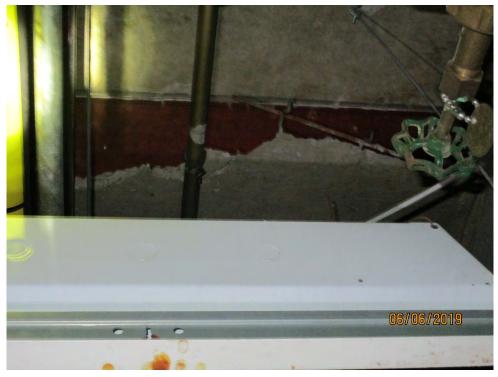
PHOTO 15: DELAMINATED CONCRETE AT UTILITY BAY BETWEEN BEAMS 2 AND 3

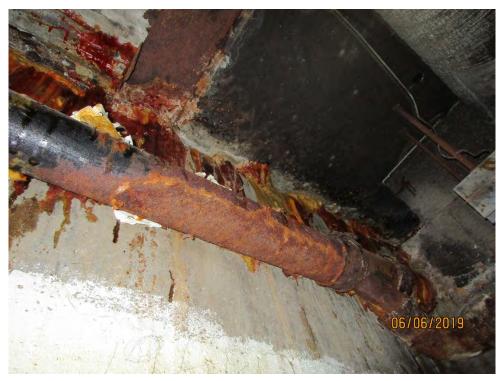
PHOTO 16: HEAVY RUST ON CONDUIT UNDER UTILITY BAY WEST OF BEAM 2

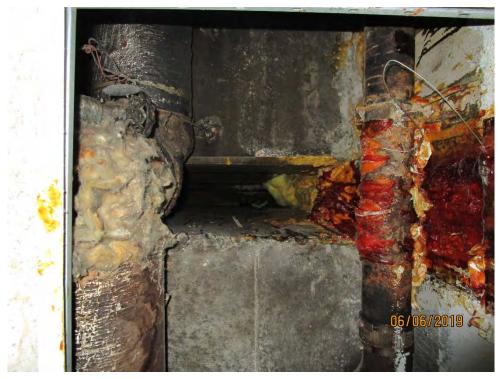
PHOTO 17: WATER INFILTRATION BETWEEN EDGE BEAM 1 AND PRESTRESSED BEAM 1

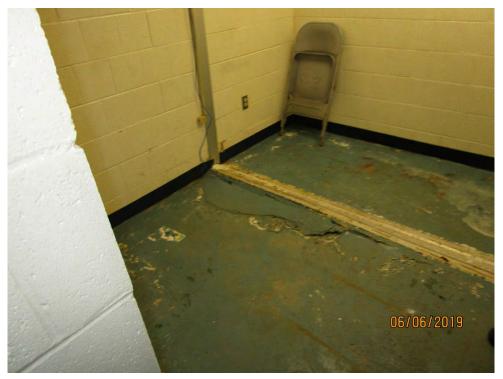
PHOTO 18: FLOOR SLAB DETERIORATION AT WEST EXPANSION JOINT

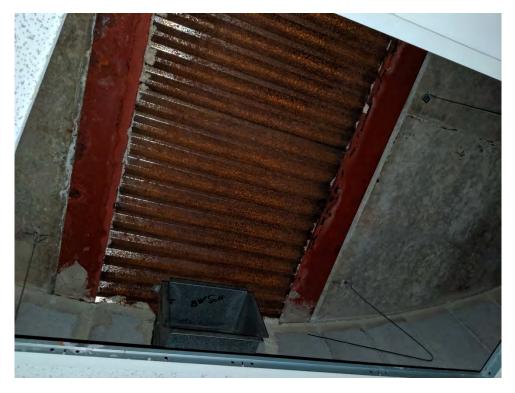
PHOTO 19: RUST AT UTILITY BAY BETWEEN BEAMS 17 AND 18

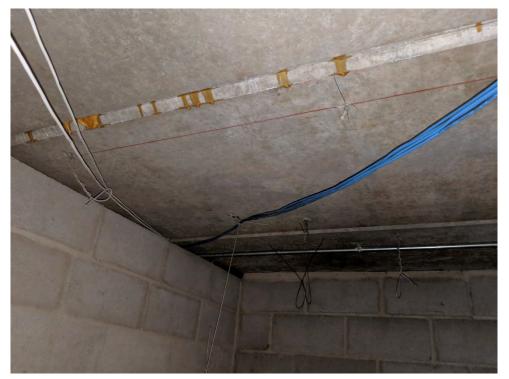
PHOTO 20: LIGHT LEAKAGE BETWEEN BEAM 21 AND 22 AT QUARTER POINT OF SPAN

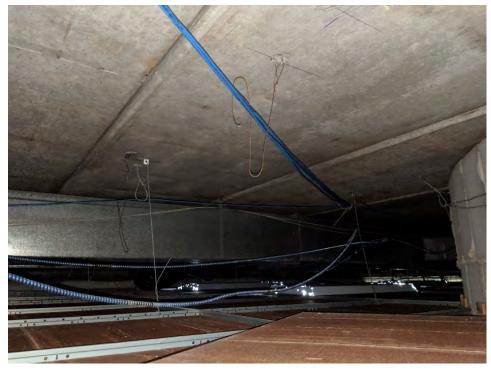
PHOTO 21: TYPICAL CONDITION OF UNDERSIDE OF PRESTRESSED CONCRETE BOX BEAMS

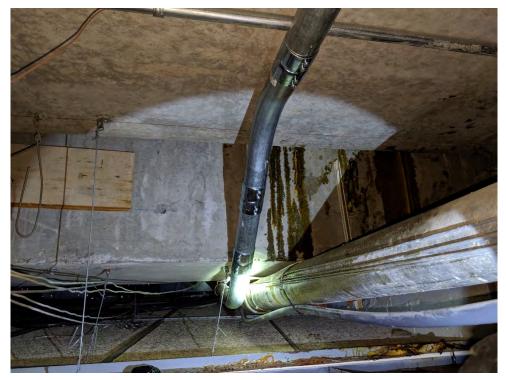
PHOTO 23: WATER INFILTRATION BETWEEN EDGE BEAM 1 AND PRESTRESSED BEAM 1

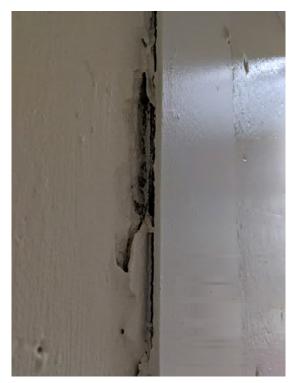
PHOTO 24: LAMINATED RUST AT SW CORNER OF SOUTH ABUTMENT EXPANSION JOINT

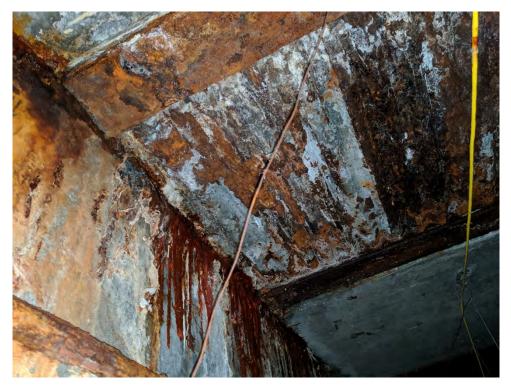
PHOTO 26: HEAVY RUST AND EFFLORESCENCE BETWEEN BEAMS 2 AND 3 AT SOUTH ABUTMENT

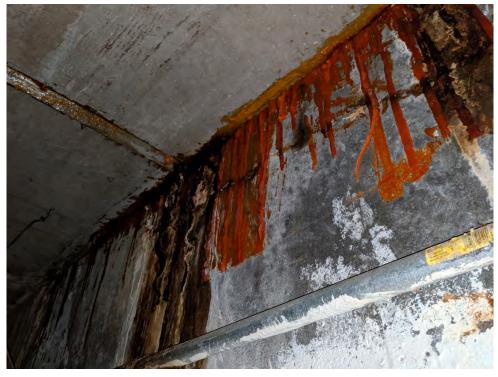
PHOTO 27: WATER INFILTRATION BETWEEN BEAMS 3 AND 4 AT SOUTH ABUTMENT

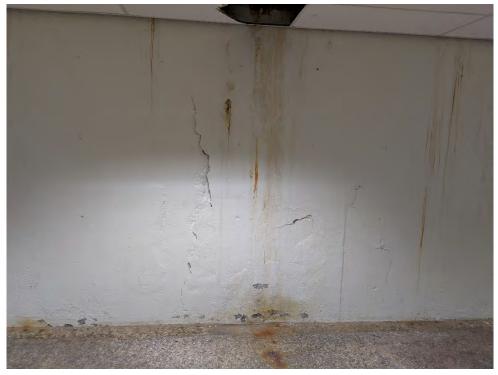
PHOTO 29: RUST STAINING BELOW CURB LINE UNDER BEAM 3 AT SOUTH ABUTMENT

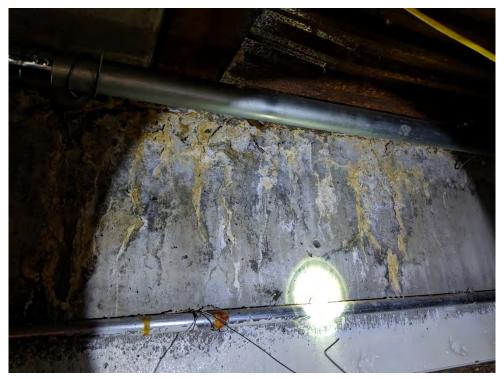
PHOTO 30: EFFLORESCENCE AT UTILITY BAY EAST OF BEAM 17 AT SOUTH ABUTMENT

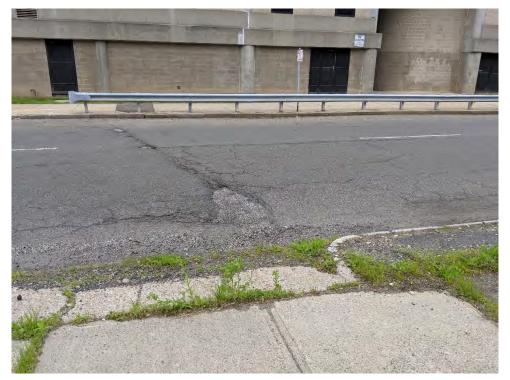
Bituminous Concrete Pavement – The bituminous concrete pavement across the bridge exhibits several areas of cracking, open up to 1" wide. There is a section on the east side of the roadway that has been cut open for previous testing and patched. There is a pothole adjacent to this patch that has been filled with bituminous material. There are cracks along the bridge joints over both the north and south abutments. These cracks extend across the entire roadway.

PHOTO 34: CRACKS IN PAVEMENT ON BIRNIE AVENUE OVER SOUTH ABUTMENT
