# York Street Jail Adaptive Re-Use Study

Prepared for: MassDevelopment

> Prepared by: Arrowstreet

1 June 2007

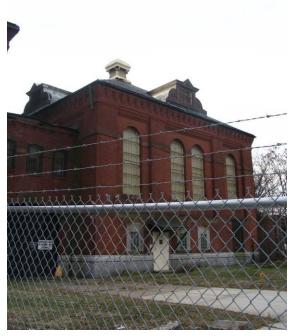
**Building 1 – North Elevation**

space one half level above grade, with arched two story windows on the south and north elevations. Existing finishes are deteriorated; existing wood windows are rotted. Since the finished floor level is above grade, ramping or a lift would be required to meet current accessibility codes. New stairs would need to replace existing stairs, which are deteriorated and do not meet code. Insulation would be required at walls and roof to meet new energy codes. A full MEP system would need to be added. The masonry basement level, currently divided by bearing walls and columns, might be best cleaned up and retained as support for the upper floor use. Exterior window openings at that level are minimal. Despite the need for these renovation upgrades, the first floor space offers potential by virtue of its volume and light.

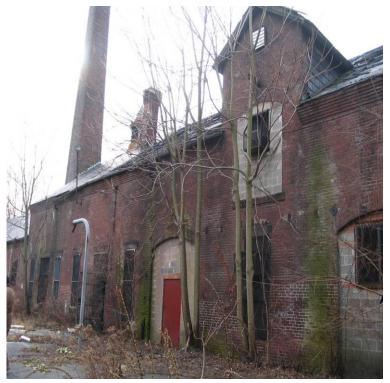
**Buildings 4, 5 and 6: Former Support Buildings**

Building 4 formerly housed containment cells and support cells on the first floor and guards' sleeping quarters on the upper floor. Building 5 housed the boiler plant. The existing rusted and outdated equipment remains and is a half level

below grade. Building 6 was the machine shop. It is boarded up and was not accessible during the site visits.

Like the other buildings in the complex, these structures and finishes are substantially deteriorated. They also lack the large windows, significant building area, large volumes, and distinctive features that could make renovation desirable. Based on the level of deterioration and the uncertain nature of future re-use options, this Study has proposed removal of the buildings to open the courtyard toward the river and provide space for parking.

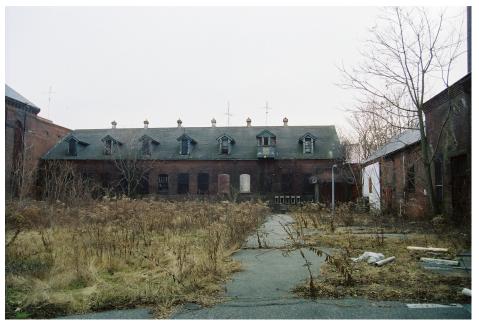
**Building 7: Former Cafeteria and Kitchen**

This former kitchen / cafeteria has a column-less first floor with large windows that open out to the courtyard on the north and gymnasium building on the south. The basement has few windows and closely spaced brick columns. The attic level has dormers along its length. While several first floor windows are currently boarded up, existing windows are large and face north and south. This building has good renovation potential based on its location on the site, proportions, and large window openings. It will need roof and window replacement, accessibility upgrades, the addition of a full MEP/FP system, and refurbishment of existing finishes.

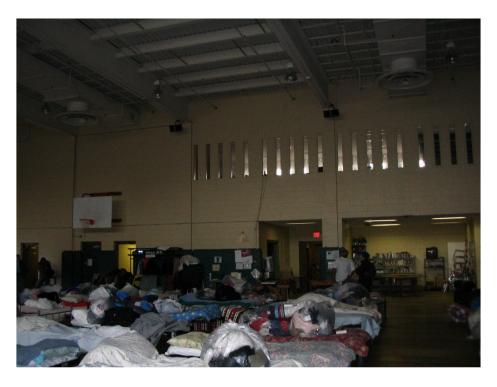
Interior – Former Gymnasium

Building 9, a former gymnasium building built in 1987, is a relatively new structure and is currently occupied by a homeless shelter. It is a two story brick building with narrow slit windows on the east elevation, a concrete foundation, and a flat roof. The roof is framed by steel bar joists and metal deck which span the masonry exterior walls. The concrete floor slab is supported on steel framing to steel columns in the crawl space. The framing, interior finishes, and exterior building materials are in good condition. In potential building re-use scenarios, new window openings will likely be required. Depending on the construction of the existing masonry walls. The new windows will require additional steel framing of the new masonry openings and may also require seismic bracing to meet current code requirements.

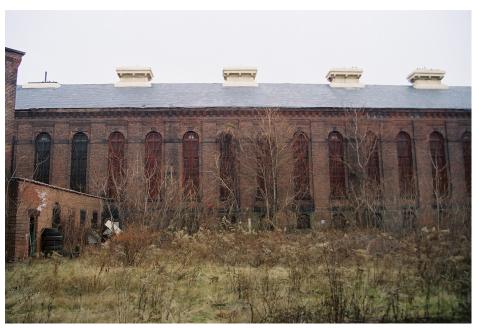
**Building 10: Former Men's Cell Block**

The former men's cell block, Building 10, and the former women's cell block, Building 13, are substantial masonry structures housing four levels of jail cells. The 6' x 8' cells are separated by 12"-16" thick masonry walls and divided down the length of the building center by a masonry wall which acts as a mechanical chase and supports the roof structure. The cells are accessed by metal walkways which are in a state of disrepair from water leakage, most likely from the deteriorated roof above. The three–story, arched, single glazed exterior windows let in abundant light on both sides of the buildings. The existing wood windows are deteriorated. The attic level of Building 10 has a deteriorated, uninsulated metal roof deck. Access to the attic level of Building 13 was not available, but it is assumed to be similar. It has also been reported that the existing floor at the roof level contains asbestos fibers that will require abatement.

Renovation of the buildings will require substantial improvements including replacement of existing windows with new aluminum sash and thermo-pane glazing, repair or replacement of roofing, and insulation of walls and roof to meet the current energy code requirements. Depending on the proposed building use, some amount of acoustical treatment may be desirable on the highway side of Building 10. Because the cell blocks are a half level below the main entry building (Building 14), accessibility is an issue for any re-use. A full MEP/FP system would also need to be added.

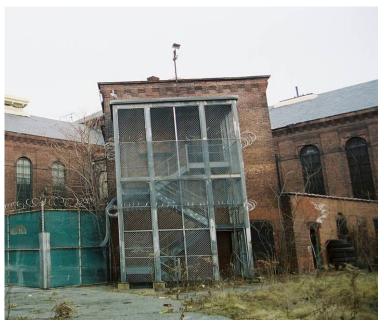
**Building 11: Former Infirmary**

Building 11, the former two story infirmary, and Building 12, a one story supply storage structure, are in a similar state of disrepair to the other buildings in the complex. They also lack the large windows, significant building area, large volumes, and distinctive features that could make renovation desirable. Their removal would open up Building 10 to the courtyard and provide a potential view of the river beyond. For the purpose of this study, it is assumed that the buildings will be removed under a potential re-use option.

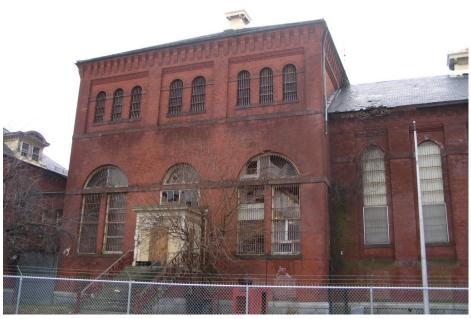
**Building 14: North Elevation**

The former entry to the jail complex retains its grandeur despite the deterioration of the building. Functionally, it was the main entry to the cellblocks and Sheriff's residence. The main entry, while grand in original design and materials (granite), is now deteriorated. The existing interior walkways, which require replacement, reinforcement, and code upgrades, open onto commanding views of the two main cellblocks (Buildings 10 & 13) and the entry space itself.

An addition, likely functional at one time, was built over the entry vestibule. It detracts from the geometry and volume of the existing main space and should be removed. Three story windows, opening predominantly toward the east and south, are wood frame with single glazing and are substantially deteriorated. A full basement and fourth floor are accessible from internal stairways.

Building 14 is dramatic, both in volume and natural lighting. The decorative foursquare of columns at its center could be refurbished or embellished to become a dramatic entry space for a restored building complex. There are also existing exposed stairways and catwalks along both sides of the space that provide views into the existing cell bock buildings 10 and 13. The stairs and catwalks are deteriorated and do not meet code requirements for a re-use option.

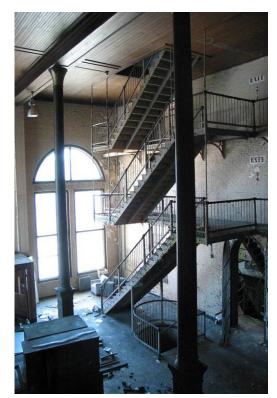
Former Reception Hall

As previously noted, the Reception Hall is a ceremonial three-story space that is one of the primary elements that should be preserved if the Jail complex is to be re-used. The Reception Hall could provide an entry lobby for either business or residential uses. There is also a one-story space above the lobby which may be useable for office or living space.

The extent of work required to renovate the space is likely to be substantial. The existing catwalks on either side of the hall will require replacement or repairs and the entire interior will need to be refinished with new MEP/FP systems provided. In addition, it is likely that the building will require structural upgrades to meet current Building Code requirements. Given the desire to preserve the character defining element of the space - decorative columns, wood paneled ceiling, floor finish, etc. - it is likely that this space will be costly to renovate properly.

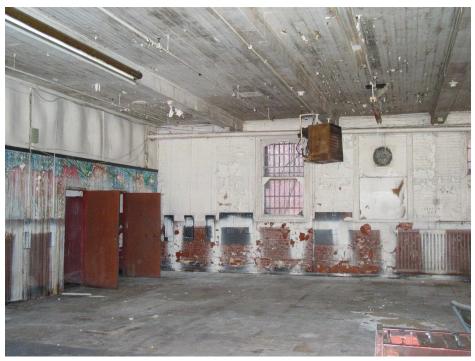
Former Cafeteria

The former Cafeteria and Kitchen Building contains a large open space with windows on both sides which would allow a variety of flexible re-use options; including office or residences. The building consists of the main cafeteria and kitchen level, a basement level space and an upper floor. The building will require substantial renovation but will help to frame the center courtyard and could remain an essential part of a future re-use project. Depending on the connection to Buildings 10, there is likely to be a need for a separate elevator and egress stair to serve the building.

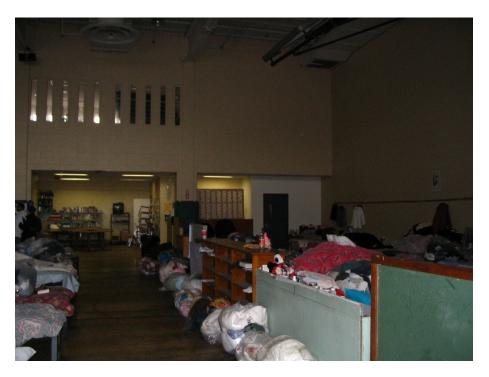
Interior - Former Gymnasium

The most economical re-use of Building 9 would be as an accessory use to the buildings proposed to remain. Should the building complex be fitted out for residents, Building 9 might become common space for the residential units, such as a health club or community building. A Class B office space building might reserve this structure for open offices, benefiting from its two-story volume. A limited service hotel could use Building 9 for its function rooms, such as ballrooms, meeting rooms, or dining (with a support kitchen). All of these re-use opportunities would require minor shell-and-core work (accessibility upgrades to the building entries) and tenant fit-up (public toilet facility upgrades, and finish updates being the major changes required). Depending on the re-use option, there may be a need for new window openings.

Currently there is a small mezzanine on the west end of the building. Depending on the re-use needs, there is also the option to add a second floor above the gymnasium space. This would require substantial structural modifications of the building. MEP/FP reconfigurations would also be needed with the addition of the second floor slab, as well as a second egress stair, an elevator, and new window openings at each level.
