PRELIMINARY ENGINEERING REPORT

Birnie Avenue Bridge / Tunnel City of Springfield, MA

September 6, 2019

City of Springfield – Department of Public Works 70 Tapley Street Springfield, MA 01104

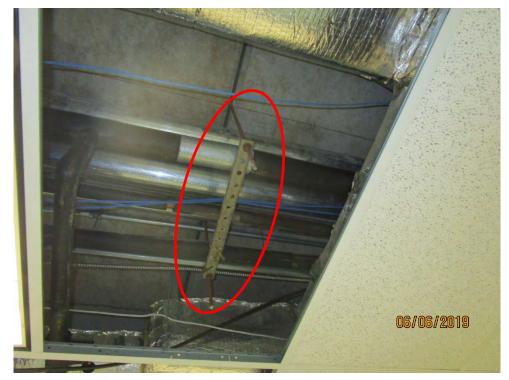
PHOTO 11: UTILITY ANCHOR ROD INSTALLED IN JOINT BETWEEN BEAMS 11 AND 12

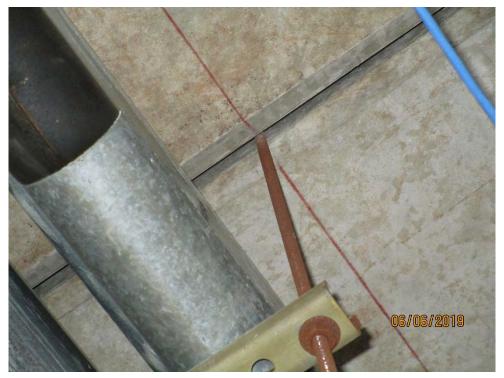
PHOTO 12: UTILITY ANCHOR ROD INSTALLED IN JOINT BETWEEN BEAMS 11 AND 12 (CLOSE-UP)

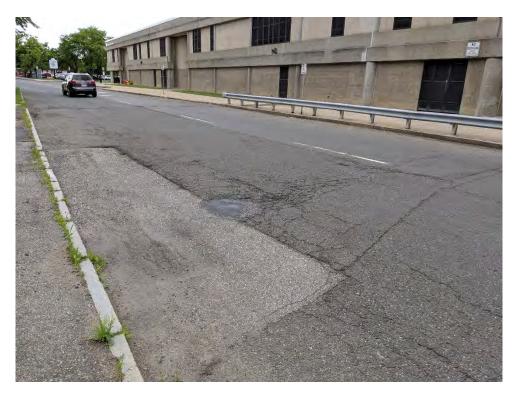
PHOTO 31: BIRNIE AVENUE AT BRIDGE LOOKING SOUTH

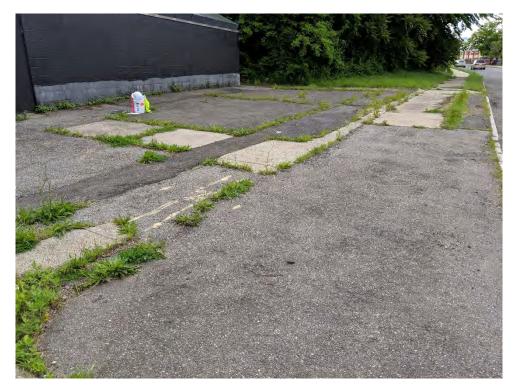
PHOTO 32: PAVED AREA OVER BRIDGE EAST OF BIRNIE AVENUE

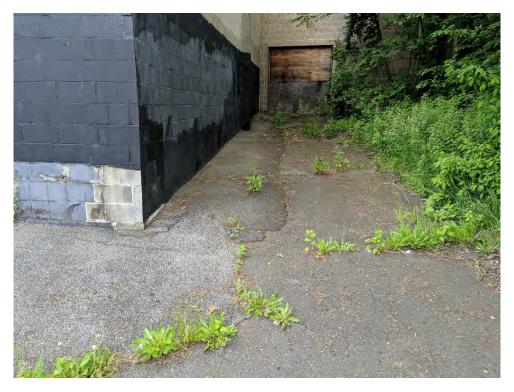
PHOTO 34: CRACKS IN PAVEMENT ON BIRNIE AVENUE OVER SOUTH ABUTMENT

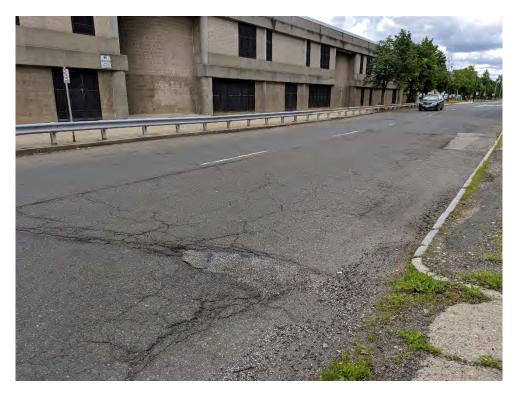
PHOTO 35: BIRNIE AVENUE OVER BRIDGE LOOKING NORTH

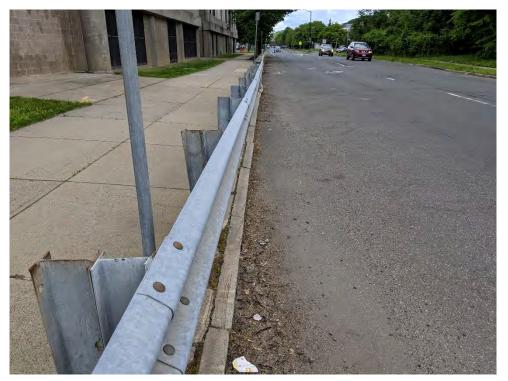
PHOTO 36: WEST SIDE OF BIRNIE AVENUE OVER BRIDGE FACING NORTH - NOTE EXISTING METAL GUIDERAIL

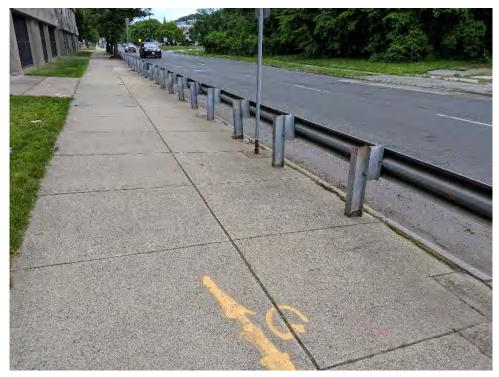
PHOTO 37: WEST SIDEWALK ON BIRNIE AVENUE AT BRIDGE FACING NORTH

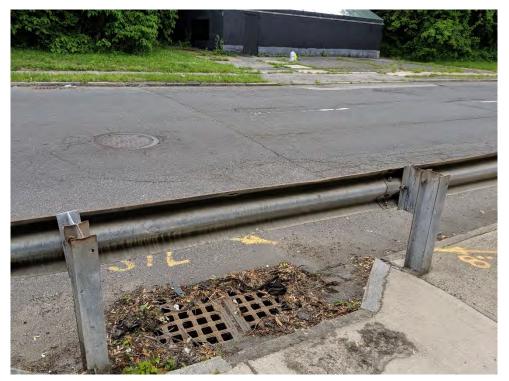
PHOTO 38: STORM DRAIN ON BIRNIE AVENUE AT NORTHWEST CORNER OF BRIDGE
